Urban Search & Rescue Virginia Task Force 2

VOLUME 2, ISSUE 1

JANUARY 2010

USAR Operations at ConAgra Industrial Explosion

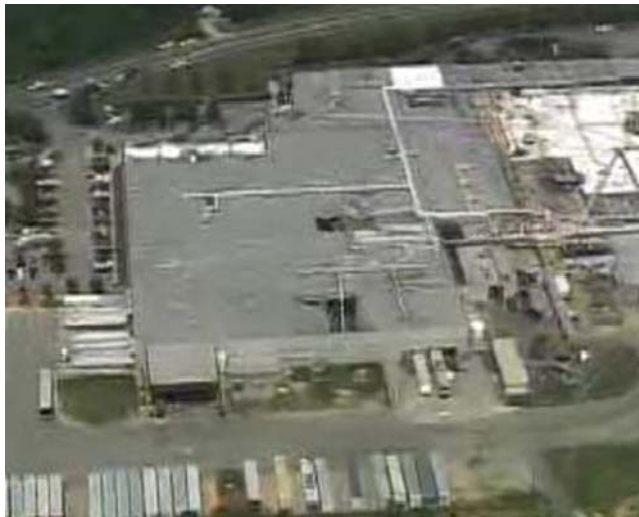
Picture @ Top Right;
USAR Personnel
Access Structural
Damage Where Ex-
terior Walls Blow-
Out, Collapsing The
Roof Structure.

“The blast blew out wall panels at two ends of the plant, and pulverized and collapsed the overhead double-tees over several structural bays.”

The Packaging Area structure included 24' tall concrete columns supporting precast concrete girders and precast concrete double-tees, with 30' tall precast concrete wall panels. The blast blew out wall panels at two ends of the plant, and pulverized and collapsed the overhead double-tees over several structural bays. Ruptured piping included large refrigeration lines that filled the wrecked space with ammonia gas.

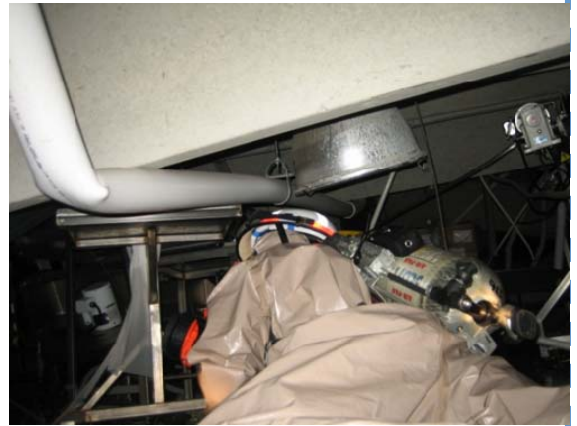
Picture @
Bottom
Right;
USAR Mem-
bers Work
Their Way
Throughout
The Struc-
ture Search-
ing For Vic-
tims.

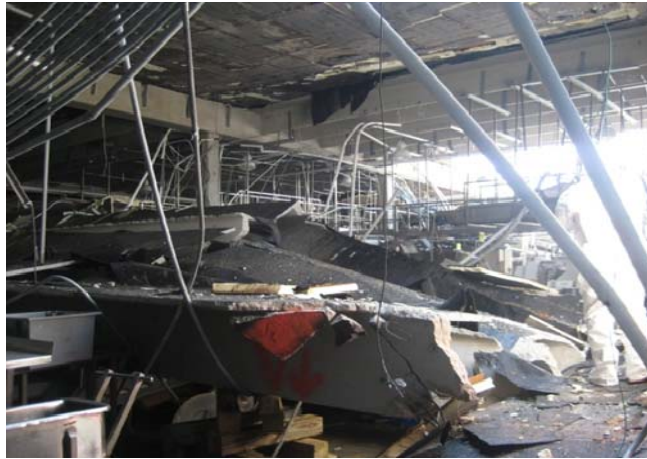
Picture @ Top Left;
Collapse Area
Where Victims
Were Located.

By daylight, the probable victim area had been thoroughly searched and operations moved to other collapse areas nearby. Crane operations began, to uncover Victim 2, and this victim was extricated by 1000 hrs. Victim 3 was finally located by about 1400 hrs. about 120' away from the victim's work area. All three of the victims appeared to have been killed

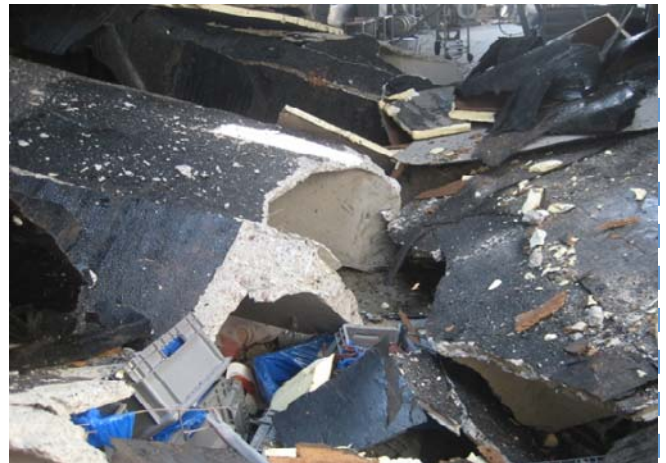
“All three of the victims appeared to have been killed suddenly by falling debris.”

Picture @ Bottom Right;
Victims Trapped & Killed By Heavy Structural Members.
